Sauna Craft heater Trouble Shooting

Typical causes for hi limit nuisance tripping:

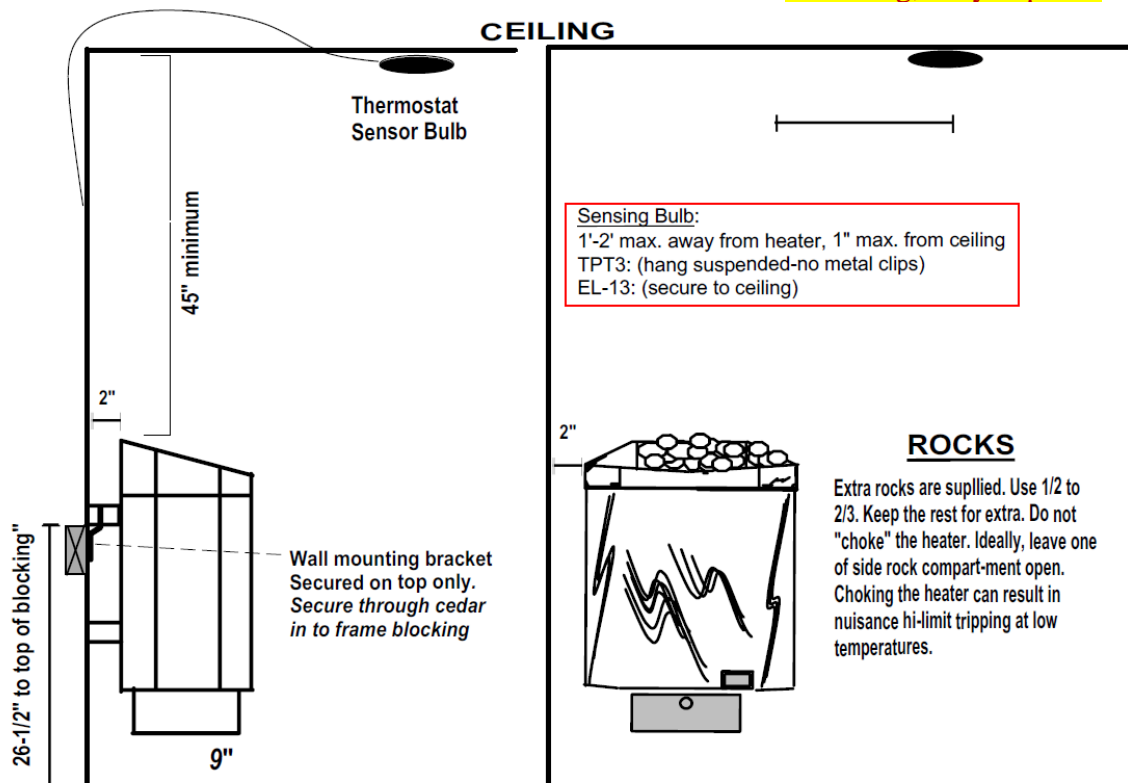
At ceiling, fully exposed

1. There must be no rocks in one of the side chambers of rock tray.
2. Thermostat sensor is too low or too far from heater.
3. Thermostat sensor must be completely unencumbered. No cover, shield or clip holding it in place. And entire sensor bulb must be inside the cedar-it can not be partially recessed
